Title: Sheet 1 of 1
Vector Brake Assy V2

Drg. No. & Revision: 1050.M.01.01.00_10.Exp

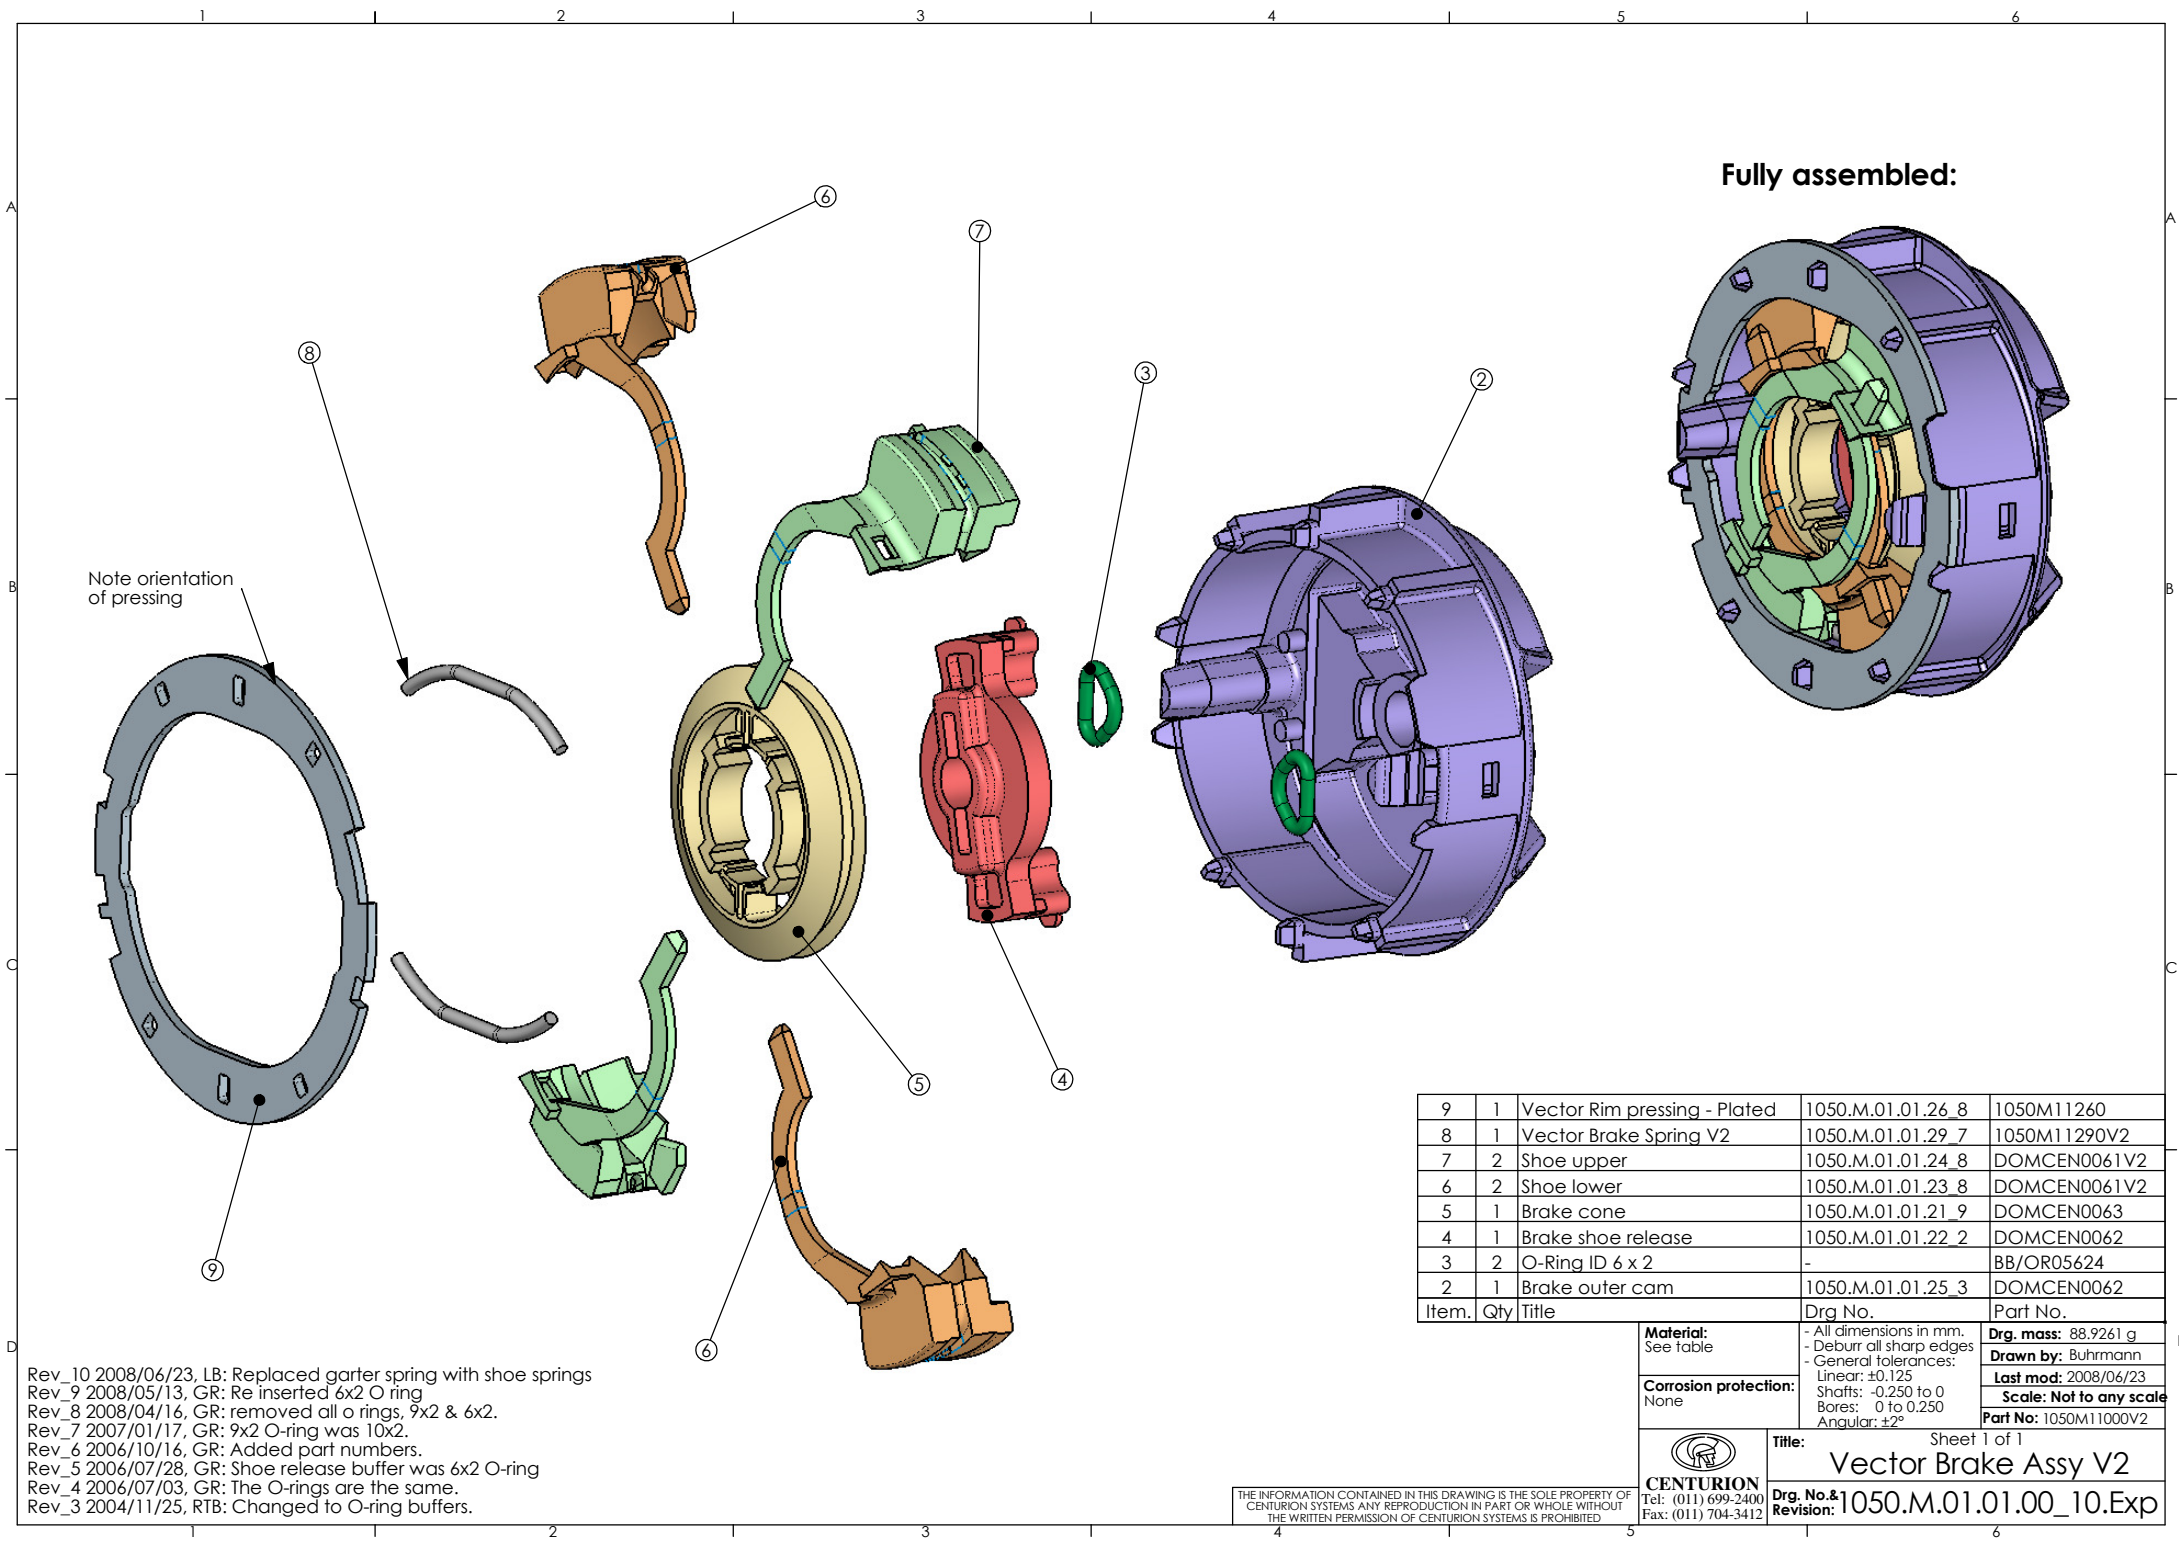
Fully assembled:

Note orientation of pressing

9	1	Vector Rim pressing - Plated	1050.M.01.01.26_8	1050M11260
8	1	Vector Brake Spring V2	1050.M.01.01.29_7	1050M11290V2
7	2	Shoe upper	1050.M.01.01.24_8	DOMCEN0061V2
6	2	Shoe lower	1050.M.01.01.23_8	DOMCEN0061V2
5	1	Brake cone	1050.M.01.01.21_9	DOMCEN0063
4	1	Brake shoe release	1050.M.01.01.22_2	DOMCEN0062
3	2	O-Ring ID 6 x 2	-	BB/OR05624
2	1	Brake outer cam	1050.M.01.01.25_3	DOMCEN0062
Item. Qty		Title	Drg No.	Part No.
